The Motu Kota Assembly wants to improve water supply and its governance in the nine Motu Koita villages. Pari village will be a demonstration village for sustainable water supply and sanitation services, which can be scaled to other Motu Koita villages. WaterAid PNG is assisting with the technical and governance aspects in Pari, with funding from the Australian Department of Foreign Affairs and Trade (DFAT) Water for Women program.

A baseline survey of all 501 households in and near Pari village was conducted in July 2021, to better understand the water supply, sanitation and hygiene (WASH) facilities and conditions, household WASH service levels, willingness to pay for an improved piped water service and a range of social indicators that are key to the provision sustainable WASH services. The baseline survey informs WASH service improvements in Pari.

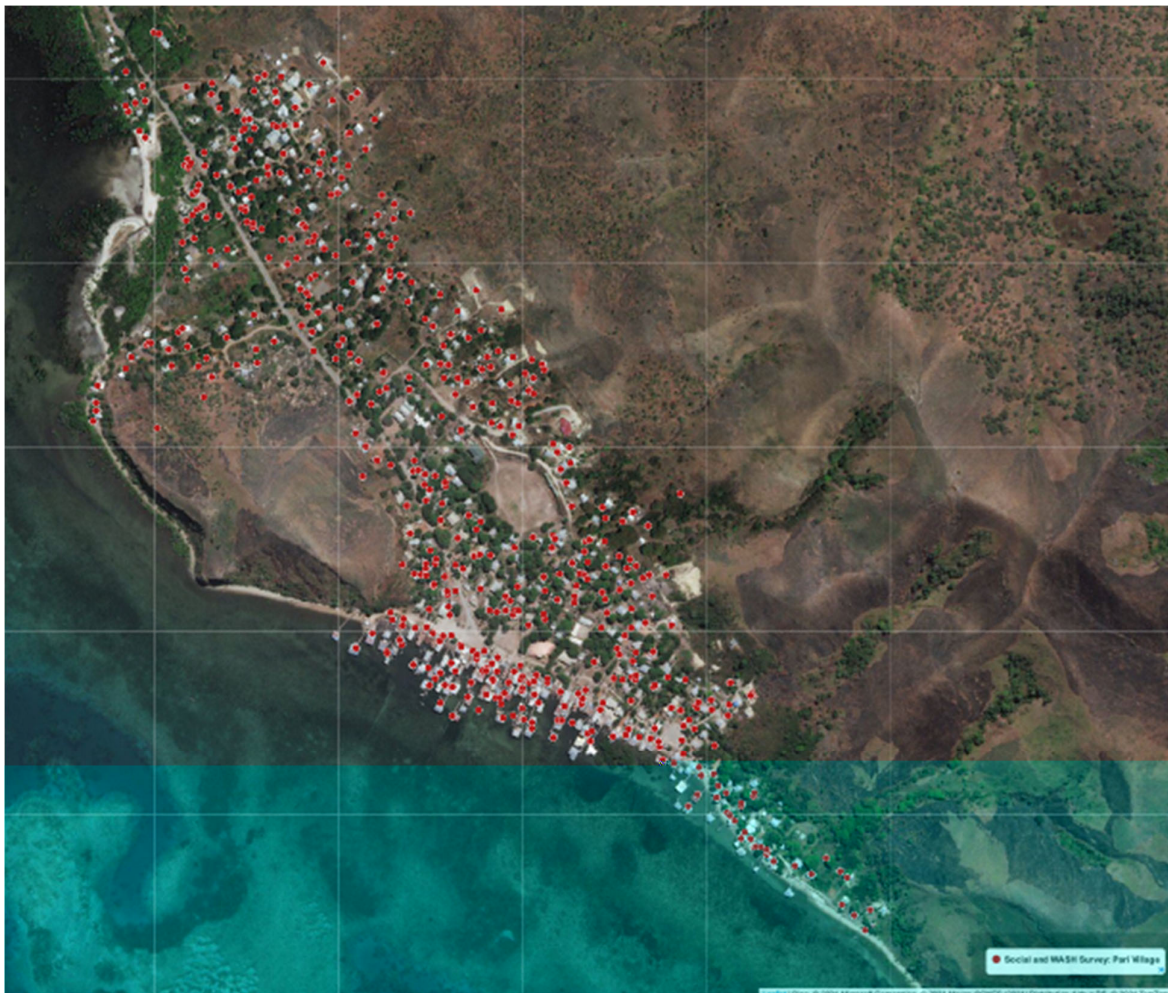
Figure 1 Location of household surveys in Pari village

Every household was given the option to refuse to take part in the survey, however no household refused. A total of 501 households were interviewed (see Figure 1). Interviews were conducted with 501 adult members of households. Respondents were 49.9% male, 49.1% female, and 1% other. 75.2% of surveys were from Pari Taoata electorate, and 4.8% from Pari Taurama. The distribution of households by section is shown in Table 1.²

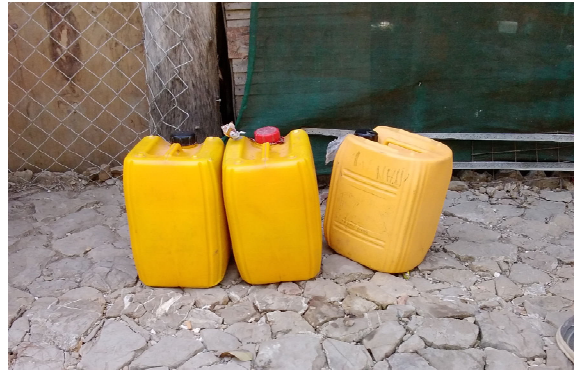
Figure 8 "Bottled" water are jerry cans

Figure 9 shows the complex water supply situation currently in Pari village and that there are multiple water sources. Most households use bottled water, which in reality is water in jerry cans, not purified bottled water. Water collections/deliveries from tanker trucks, bottled water (jerry cans), and water boys account for 76% of all drinking water. The water quality and safety of these informal sources is not guaranteed.

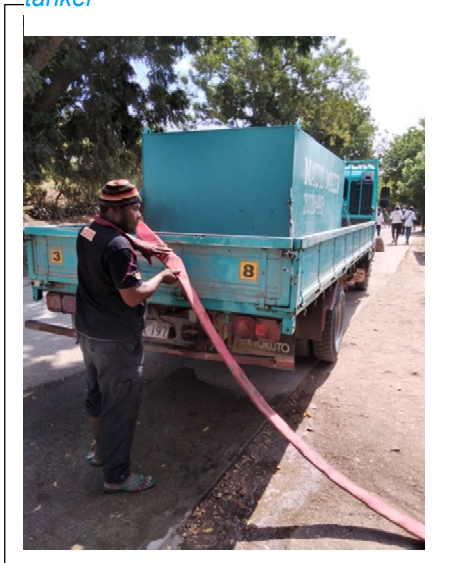
Figure 11 Water delivered by private tanker

Water deliveries are also made by private water tankers as depicted in Figure 11.

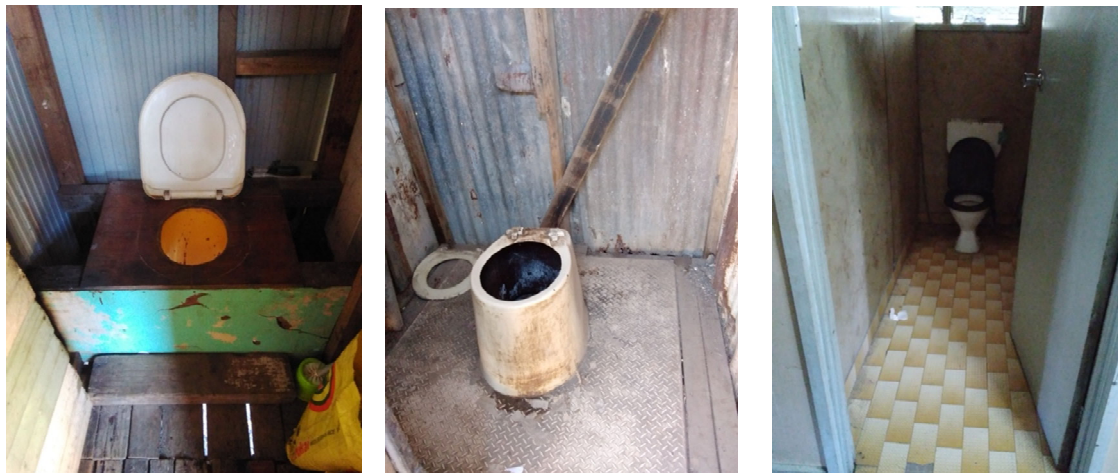
Figure 24 Examples of toilets, Pari

There is a variety of toilets used by households in Pari. The most common types are pit latrine with slab (32%), and pit latrine without a slab (17%) (refer to Figure 23 and Figure 24).

L to R: Hanging toilet, pit latrine with metal slab, flush to pit

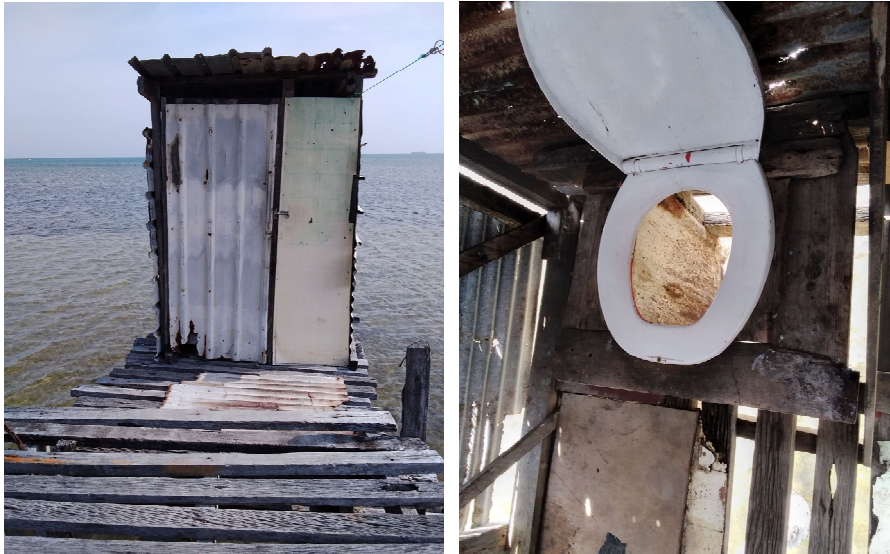
Figure 25 Hanging toilet

Sanitation is poor in Pari. At least half the toilets are unimproved (pit latrine without slab 17%, hanging toilet 24%) or no facility (9%). Hanging toilets are prevalent but provide no barrier between faeces and human contact and present a serious health hazard. Three quarters of households are interested in upgrading their toilet, with 59% of them very likely to upgrade the toilet within the next 6 months. The survey confirms a need to improve sanitation, and some initial support from households, which should be explored further.

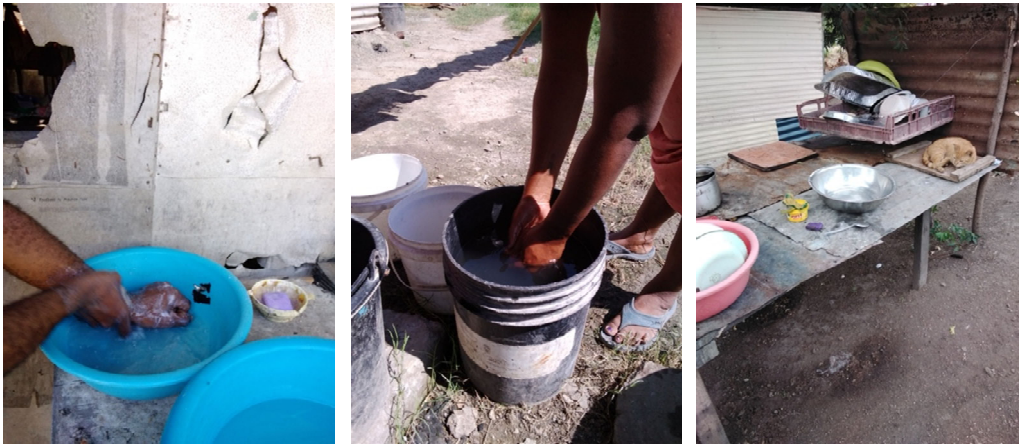
Figure 32 Handwashing facilities - Pari

Handwashing practice seems to be well known, even by young children (refer Figure 32 and Figure 33).

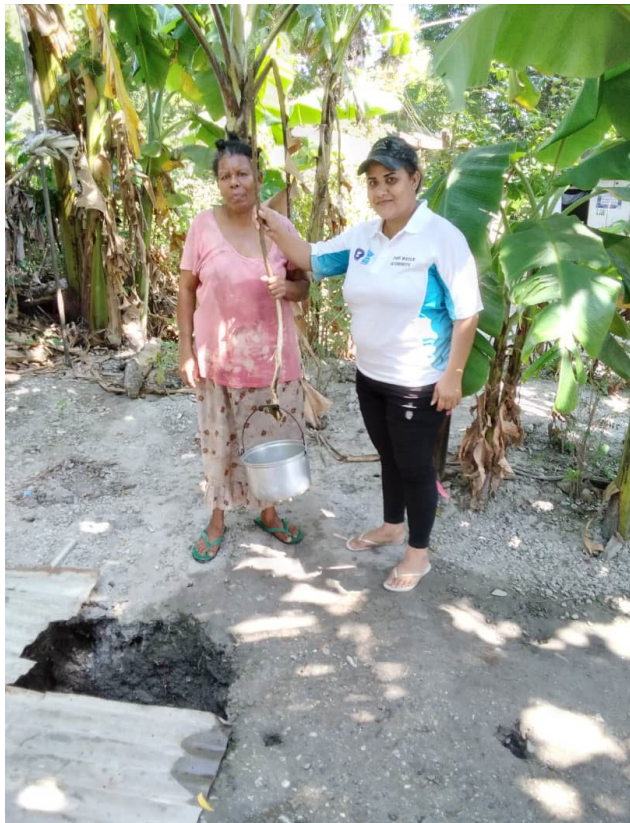
This hardworking mother earns her daily living through selling her unprotected spring water near her yard. The water is used for washing and doing laundry.

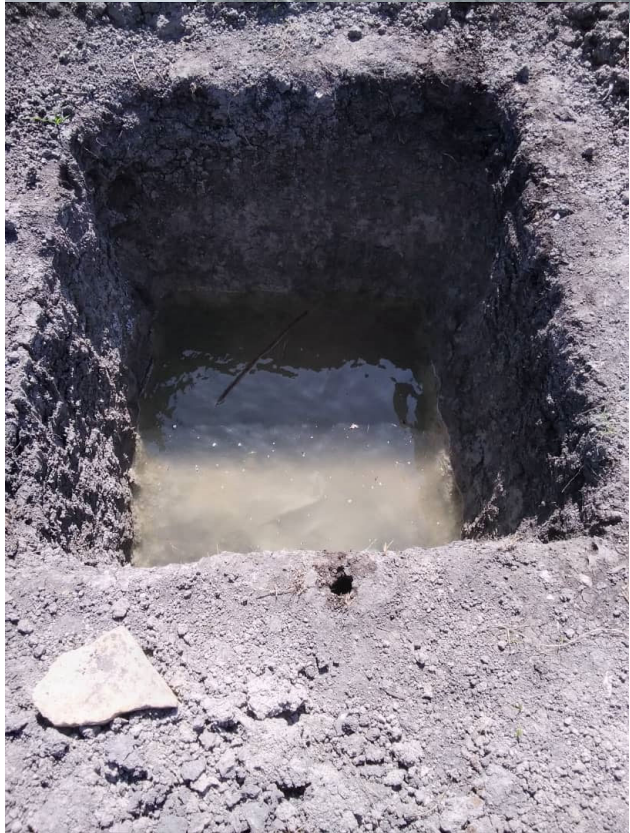
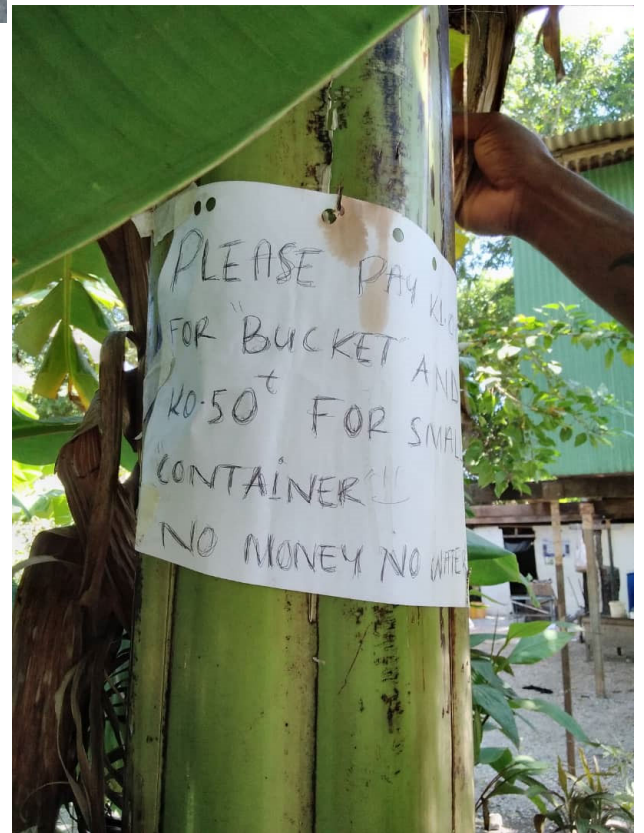
The unprotected spring and payment instructions.

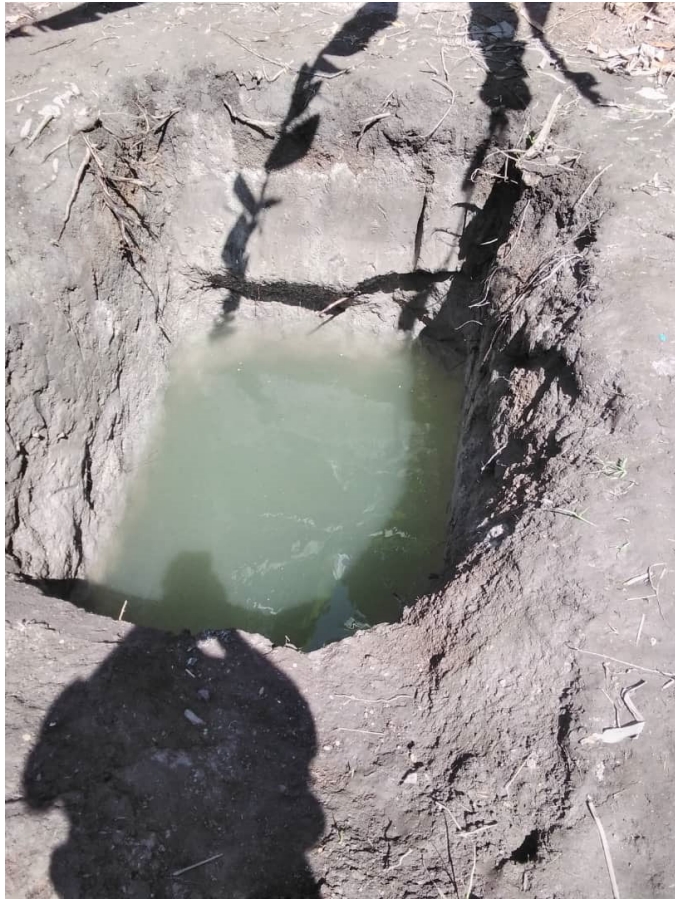
This recently dug well (unprotected) is helping a lot of people at Doru (Bethel and Horab). It is mostly used for bathing and laundry.

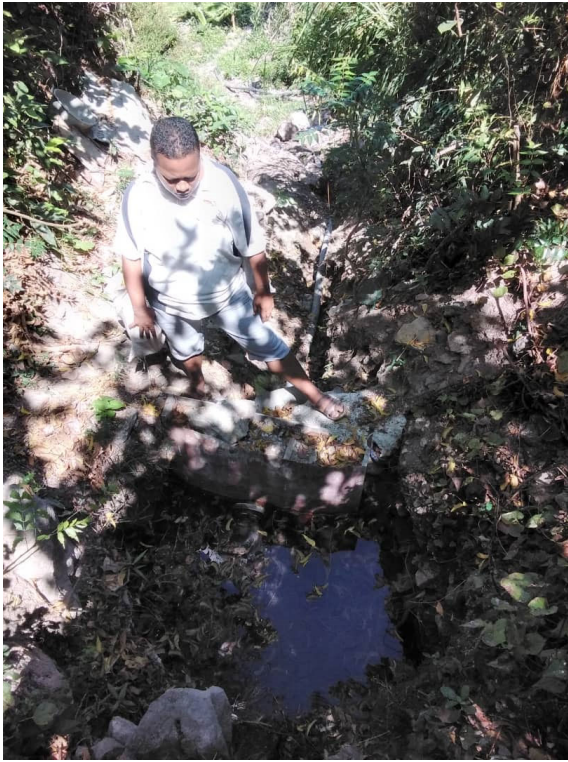
Appearances are deceptive. Water is collected from this spring and stored in large tuffa tanks and then distributed to taps.

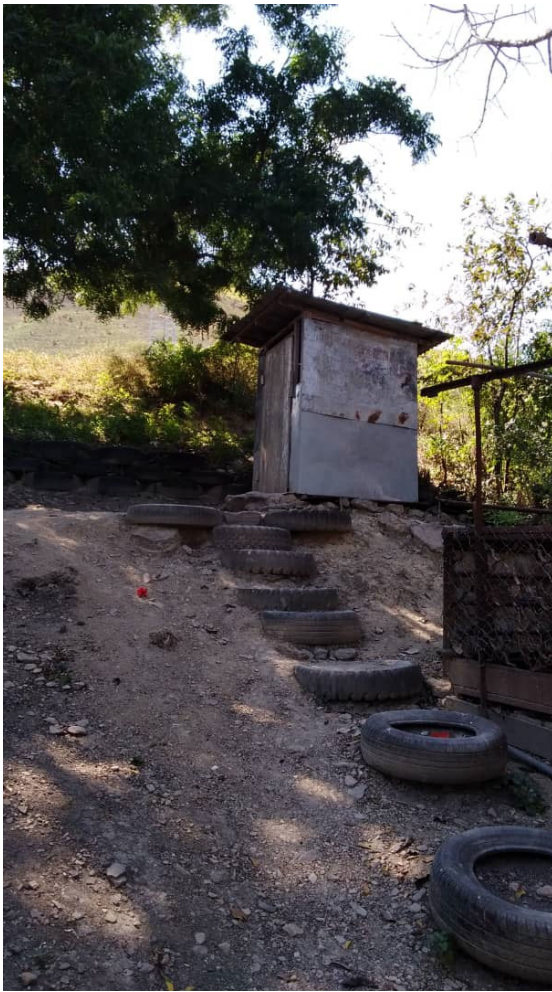
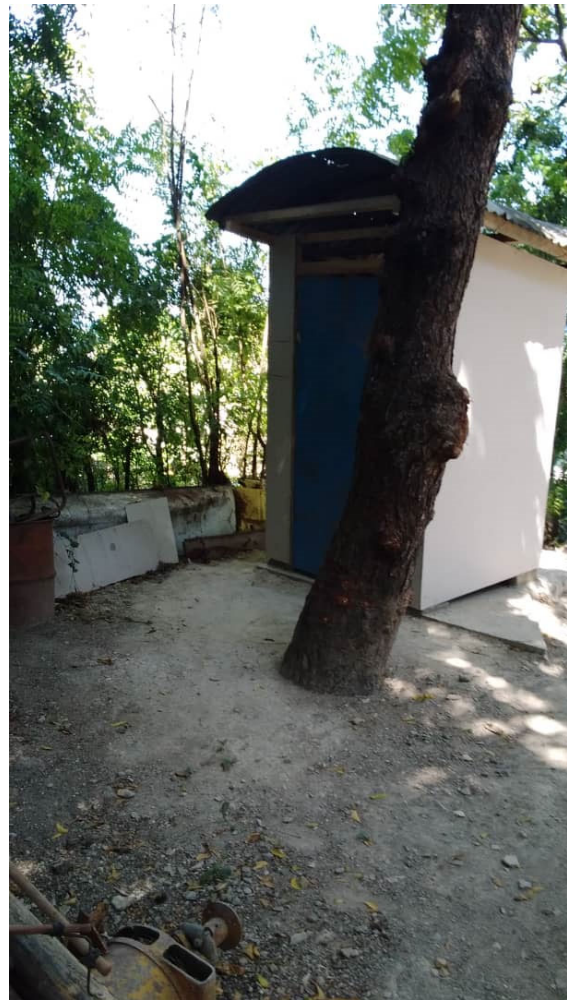
Left: An example of a dry pit latrine, which can be used any time.
Right: A septic tank toilet which is only used when the water is flowing.
